# A Plan for the Conservation and Re-use of the Blue Cabin

Submitted to the Blue Cabin Committee

Harold Kalman with Andrew Todd Conservators Ltd.

February 2016

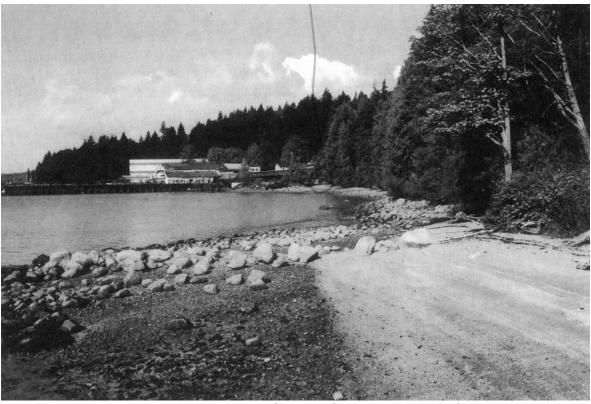
The McKenzie Barge and Dollarton Shipyard properties, facing west from the Cates Park wharf. The cabin is located on the foreshore, below the vertical line drawn in the sky. (Carole Itter, ca. 1990s)

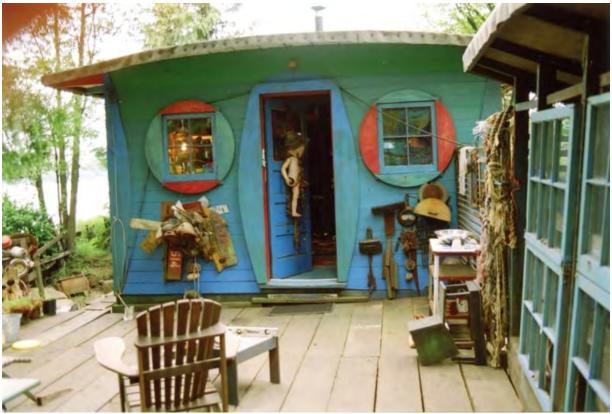
The entrance to the cabin and the deck, with storage to the right, looking south, 1996. (Carole Itter)

The construction is conventional timber framing. The details, however, are quite eccentric, made remarkable by the many curved features. The roof is bowed, in the form of a low ellipse, supported by rafters having curved top edges. The window and door surrounds are segmental in form, with the four segments around the windows forming a circle. The exterior corner boards were also segmental. These features are surely original (they were in place when Neil took over the cabin in 1966). They were evidently playful, signature features of the craftsman, reportedly Scandinavian, who built the cabin as his home.

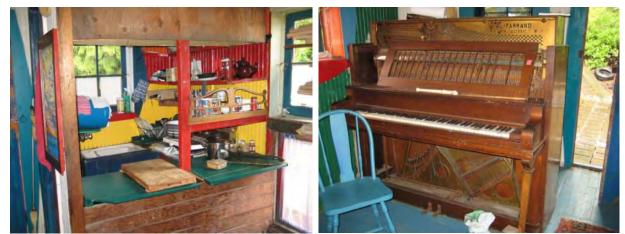
The interior is essentially a single space, with the only subdivided feature being a kitchen alcove in one corner. The space was dominated by the tools of the occupants' art: Neil's upright piano and Itter's drawing board, with shelves behind it to hold her paints and supplies. The cabin also contained a wood stove and furniture for living and sleeping. The beams are painted red, blue, and green. The walls are partly green, partly natural wood, and partly panelled with other finishes.

Interior views: Left, the kitchen alcove; right, Al Neil's piano, which was given to artist Luke Blackstone, both 2015. (Michael Jackson)

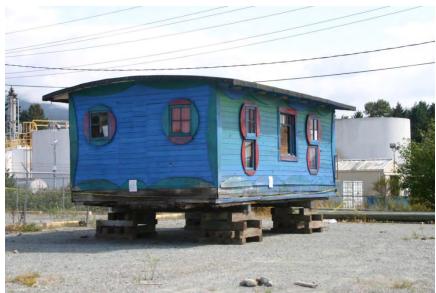
The Blue Cabin on site in the outdoor storage yard, North Vancouver, July 2015 (Andrew Todd).

In general, the Blue Cabin is structurally in good condition, although with deteriorated wood and flaking paint observed on the surfaces. The under-structure has seriously deteriorated beams and joists. Treatment to stabilize this area will be required. Protection of the Blue Cabin needs to be provided to prevent the effects of environmental free water/rain and moisture accumulation levels in the interior of the structure.

As noted, the Blue Cabin is in need of environmental protection. It is recommended that a scaffolding surround system be erected at the four corners and where required mid-span and that overhead framework scaffolding be provided and covered with a shrink wrap type of plastic fabric. (This would be similar in method to the covering currently provided for Christ Church Cathedral on Burrard Street.) It would also be a good idea to cover the sides for at least one-half the height of the building, leaving the bottom open for circulation of air.

The interior of the Cabin should be supplied with a small electric heater which can maintain just enough heat to keep the interior free of moisture and condensation.

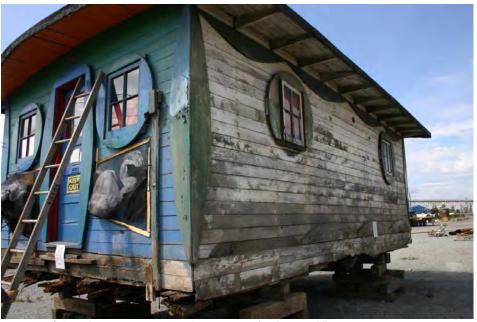
Location of the cabin in temporary outdoor storage. (Andrew Todd)

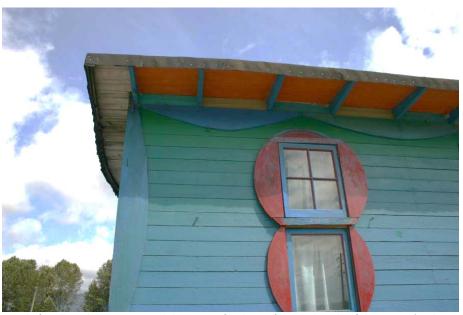
Detail of scalloped decoration and decorative finishing of the underside of the eaves. (Andrew Todd)

At the conservator's visit to the site in mid-July 2015, he became familiar with the present storage site and with the previous location along the Dollarton foreshore. An examination began with visual observation of the two locations, as well as photographs. An overall microscopic inspection was conducted. Summer weather was noted. Visual examination was well illuminated. In addition to visual examination, sound testing was conducted by rapping gently on all the wood surfaces. Sharpened blade probes were also used to determine the strength of the wood surfaces and determine how deeply penetration could be made in areas where infestation could have caused weakening and tunneling of the wood. Notes were made of all findings for future reference.

Evidence of the deterioration of structural wood from fungal rot was noted. In addition, other forms of wood decay were observed, including some evidence of sawdust ('frass') piles. Environmental conditions are relevant, since the materials in question are structural and the cabin is built on them.

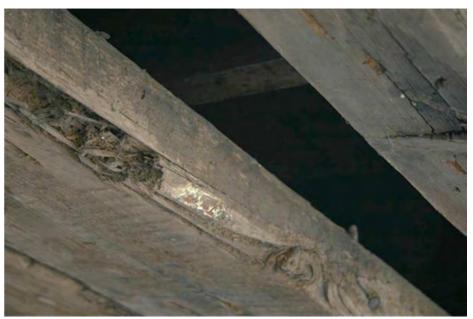
During the examination to discover the condition of the wood, the possibility of insect infestation, particularly by carpenter ants and possibly by termites, was noted. Excrement markings of other pests were not noticed. The possibility that rats had entered the cabin was considered and observations were made to discover any signs of this. None were noted.

Sample collection of deterioration factors, particularly of frass, should be made and identified. The infestation by termites is considered a slow-moving, slow-breeding, long-term threat of damage to structural beams in wood-frame buildings such as this.

Detail of brown cuboidal fungal deterioration, frass, and small flight holes of insects, possibly furniture beetle or carpenter ant. (Andrew Todd)

Subterranean termites, which live in colonies in damp or moist soil in the vicinity of wooden structures, travel to wooden members, where they grow and multiply slowly. Because they remain within the wooden members, they are difficult to observe. As a result, an infestation can only be detected by signs of frass and movement trails. Changes in weather conditions can create noticeable activity. Because these insect infestations are difficult to observe, their exact location can be hard to determine. This problem leads to difficulty in exterminating their presence.

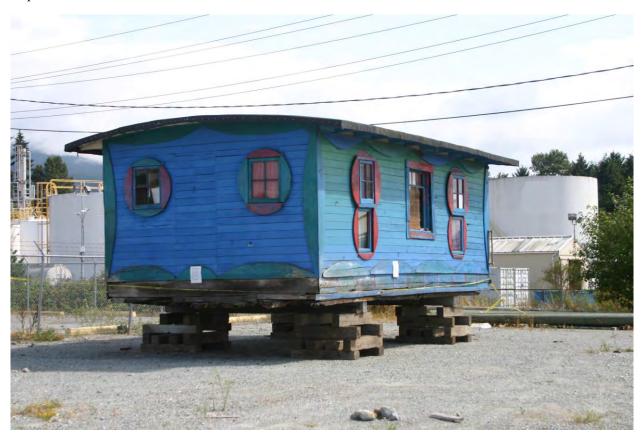
The Blue Cabin on site in outdoor storage yard, North Vancouver, July 2015

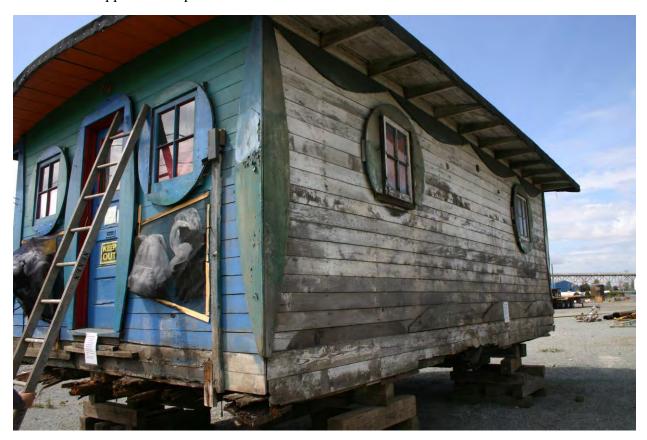
Location of the cabin in temporary outdoor storage.

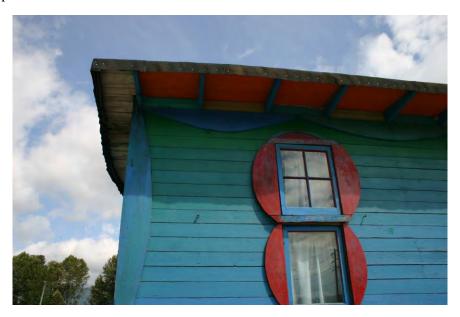
Detail of scalloped decoration and decorative finishing of the underside of the eaves.

The conservator was first able to visit the site in mid-July 2015 and at that time became familiar with the site and locations where evidence of deterioration of structural wood was noted. An examination began with visual observation of the actual original location, as well as photographs, overall microscopic inspection of the location was conducted. Visual examination was well illuminated in the area. In addition to visual examination, sound testing was conducted by rapping gently on all the wood surfaces. Sharpened blade probes were also used to determine the strength of the wood surfaces and determine how deeply penetration could be made in areas where infestation could have caused weakening and tunneling of the wood. Notes were made of all findings for future reference.

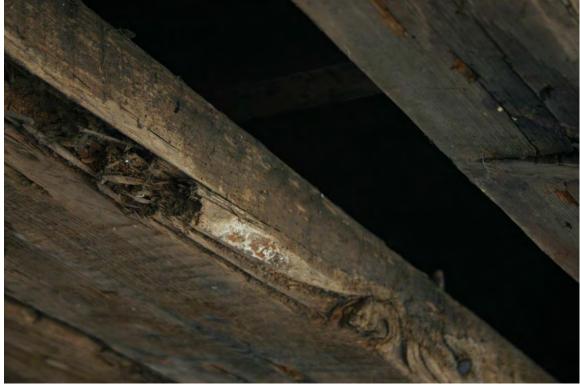
Detail of brown cuboidal fungal deterioration, frass& small flight holes of insects, possibly furniture beetle or carpenter ant.

During the examination to discover the condition of the wood, the possibility of insect infestation by particularly carpenter ants and possibly termites was noted. The excrement markings of other pests were not noticed during the exam. The possibility that rats had entered the cabin was considered and observations were made to discover any signs and none were noted.

Based on a further examination, and an assessment of the plans for the cabin, it is recommended that a conservation treatment plan be developed to consolidate and treat the cabin. Degrees of restoration include initial stabilizing of the sections of the cabin to slow the process of deterioration, as mentioned with an application of Tim-bor. The cleaning and stabilizing the exposed wood would be the next step followed by a treatment to consolidate the flaking layers of paint. Providing conservation and restoration treatment of the wood would involve consolidation and the addition of replacement parts to give new structural support systems as may be required to stabilize sections of the cabin. New wood may be required as part of the treatment for both structural and decorative pieces of the cabin.

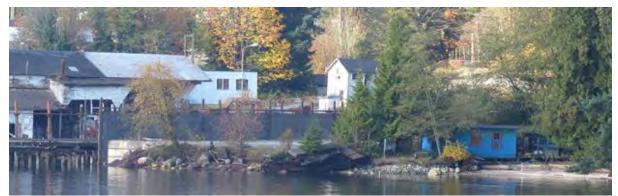
McKenzie Barge site with blue foreshore cabin on the right.

Vince Mason, one of the oldest workers at McKenzie Barge & Derrick, told Al Neil that the cabin was built by a Scandinavian craftsman in the 1930s and was originally moored on a barge in Coal Harbour. When its builder got a job at McKenzie Barge he had the cabin towed to its present location and lifted by a derrick onto pilings. The cabin became part of a small community of beach dwellers who worked at McKenzie Barge.

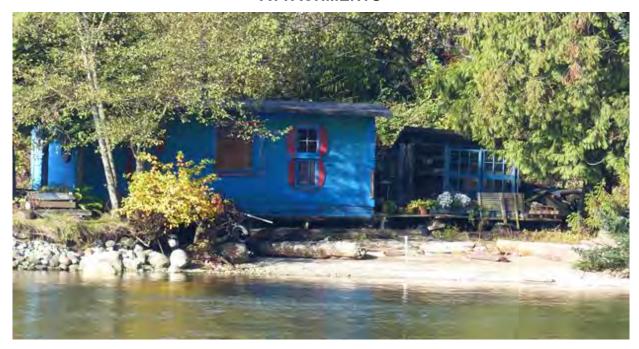
View of cabin and deck (to the right) from the water
